Folds Inspection Services

Test Field Inspection/ sun

Client(s): **John B King**
Property address: **967 US Highway 92**
Fayetteville GA 30214-3719
Inspection date: **Sunday, December 13, 2020**

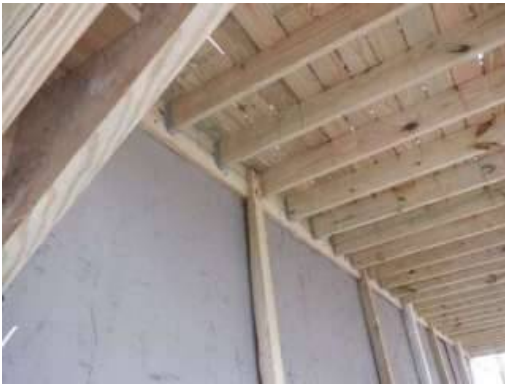
Ledger boards for one or more decks, balconies or porches appeared to be attached with nails only. This method of attachment is substandard and may result in such structures separating from the main building. This is a potential safety hazard. Modern standards call for ledger boards to be installed with 1/2 inch lag screws or bolts into solid backing, and brackets such as [Simpson Strong Tie DTT2 brackets and threaded rod](http://www.reporthost.com/?LB), connecting interior and exterior joists. Recommend that a qualified contractor repair per standard building practices. For more information, visit:

Photo 4-1 underneath deck

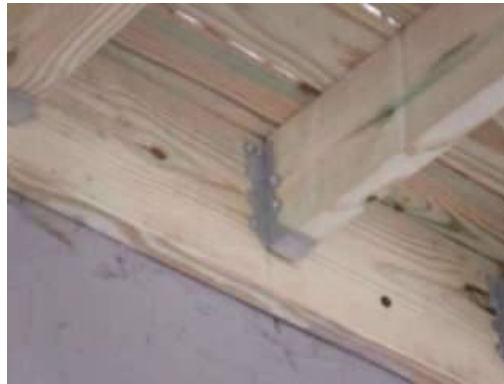
Photo 4-2 Deck bolt wrong size

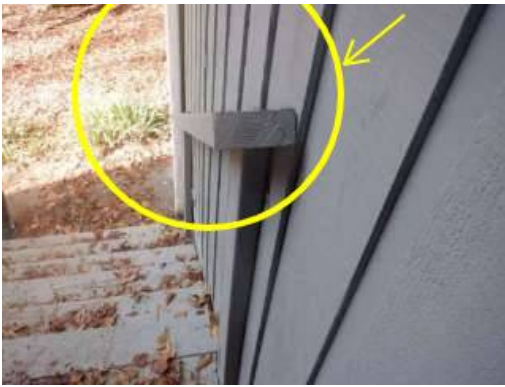
One or more handrails had no returns installed, where ends of handrails turn and connect to adjacent walls so objects or clothing will not catch on the open ends. This is a safety hazard. Recommend that a qualified person install returns per standard building practices.

Photo 6-1 Handrail with no return

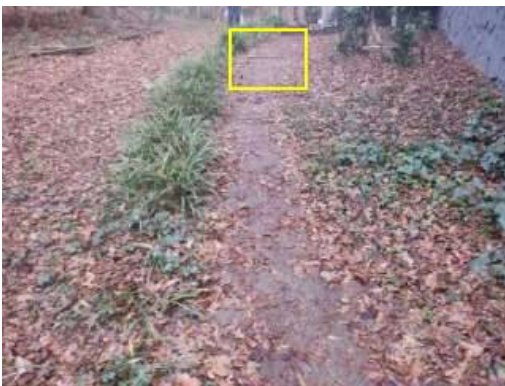
Cracks, holes, settlement, heaving and/or deterioration resulting in trip hazards were found in the driveway, For safety reasons, recommend that a qualified contractor repair as necessary.

Photo 7-1 walkway

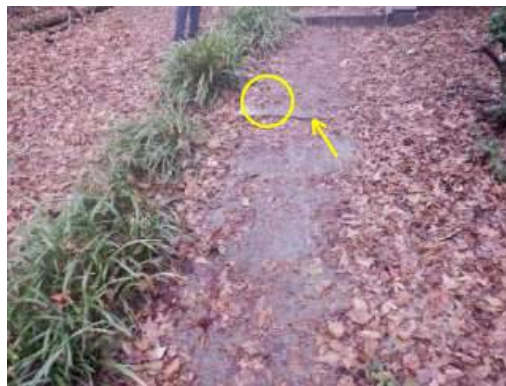
Photo 7-2 Trip hazard

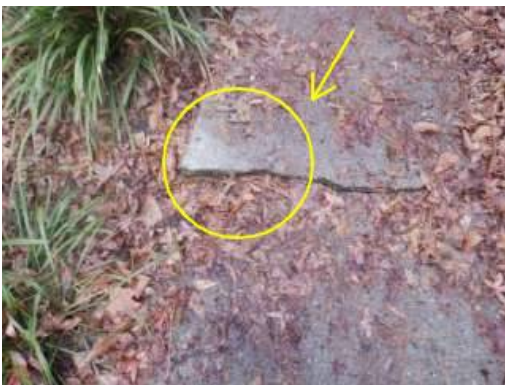
Photo 7-3 Trip hazard

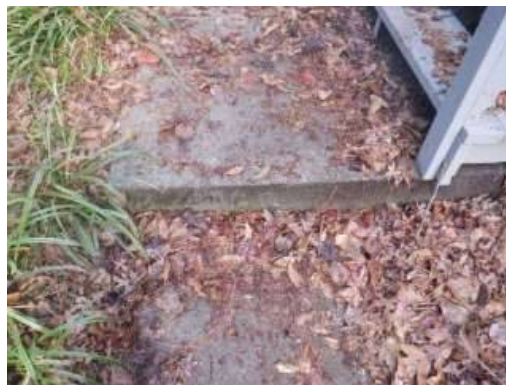
Photo 7-4 Possible Trip hazard

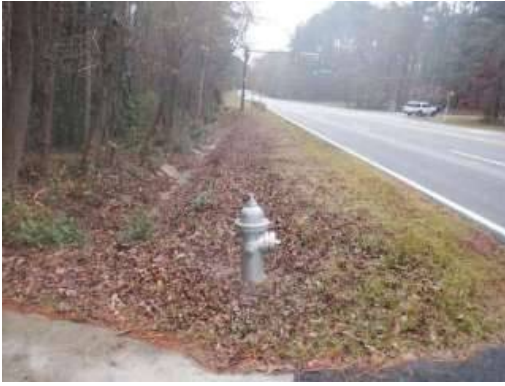
No Sidewalks

Photo 8-1 The right side of Hwy 92 N fire hydrant

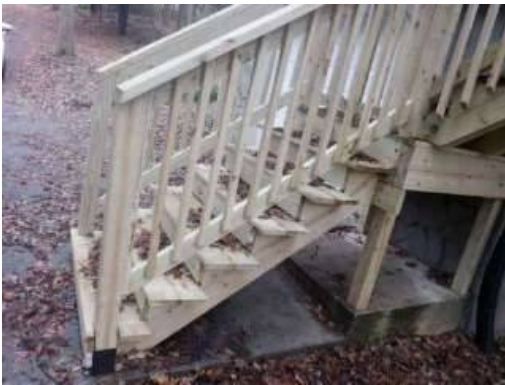
Soil was in contact with or too close to wooden deck, porch or balcony substructure components. This is a conducive condition for wood-destroying organisms. Clearances to soil should be as follows:

- 12 inches below beams
- 18 inches below joists
- 6 inches below support post bases and other wood components

Pressure treated wood is typically rated for 25 year contact with soil, but the cut ends hidden below grade may not have been treated and can rot quickly. Support posts should be elevated above grade on concrete piers or footings, and be separated from the concrete by metal brackets or an impermeable membrane such as shingle scraps. For other components, soil should be graded and/or removed to maintain these clearances if possible. Otherwise, replacing non-treated wood with treated wood, or installing borate-based products such as Impel rods may help to prevent infestation and damage. For more information, visit:

Photo 9-1 (R) side of Deck stairway

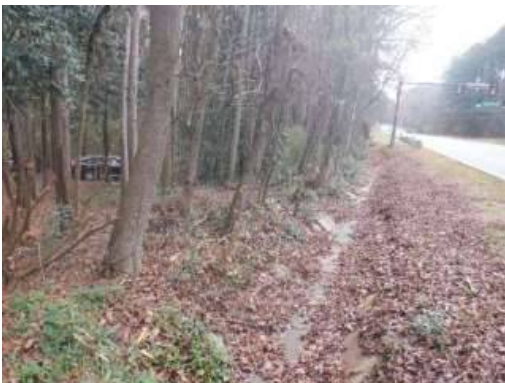
Photo 10-1 967 US Highway 92

One or more drains in the yard or landscaped areas could become clogged. Water may accumulate and become a nuisance or may flow towards the building. Recommend that a qualified person clear drains as necessary.

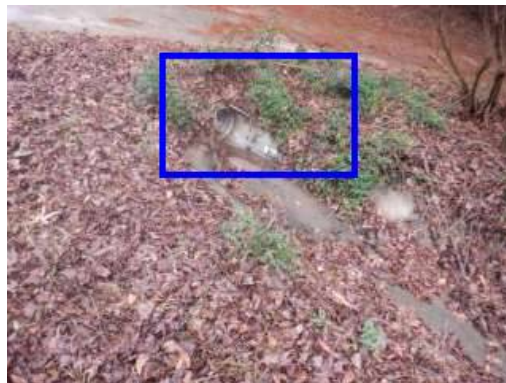
Photo 10-2 drainage easement

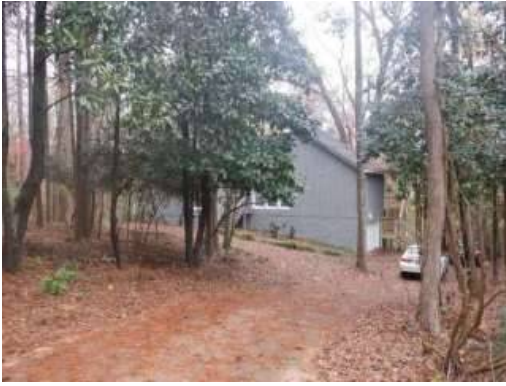
Photo 11-1

The driveway had significant growth of moss or vegetation. Recommend cleaning or removing growth to prevent deterioration.

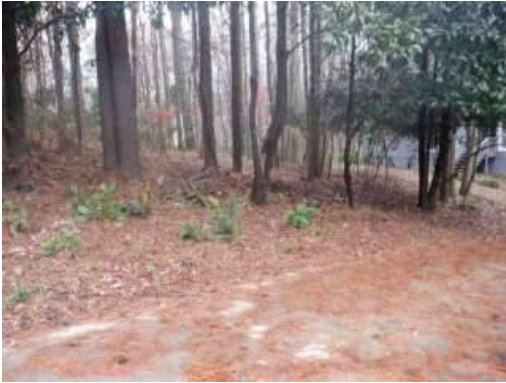
Photo 12-1

The soil or grading sloped down towards building perimeters in one or more areas. This can result in water accumulating around building foundations or underneath buildings. At a minimum, monitor these areas, and areas under the structure in the future for accumulated water. If water does accumulate, recommend grading soil so it slopes down and away from buildings with a slope of at least 1 inch per horizontal foot for at least 6 feet out from buildings.

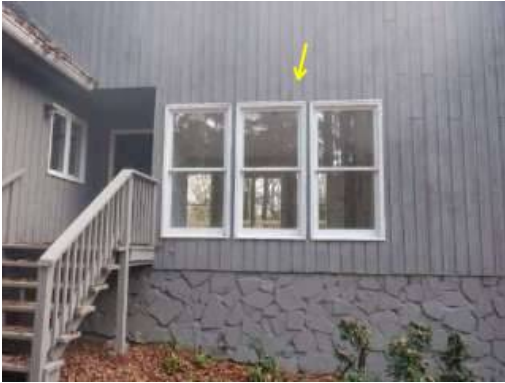
One or more windows or doors were installed with no "drip cap" or "Z" flashings installed above them. Better building practices call for such flashings, which greatly reduce the chance of leaks above windows and doors. Without this flashing, caulk and paint must be maintained or water can enter the wall structure and cause rot and possible structural damage. Depending on the exposure (e.g. roof overhang, height of exterior wall, direction of prevailing rain) this may or may not be an issue. The client should monitor these areas in the future and maintain caulk and paint as necessary. Consult with a qualified contractor about installing flashings where needed, and per standard building practices. Note that when trim or siding is removed to install flashing, damaged wood may be found and additional repairs may be needed.

Photo 16-1 Front three windows

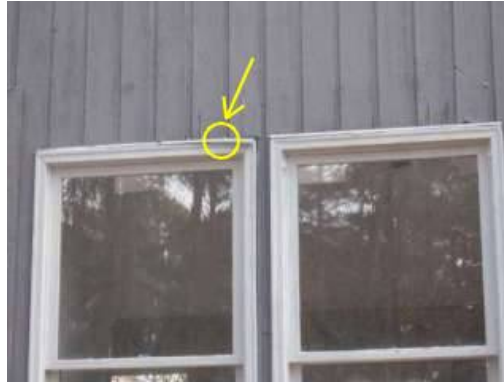
Photo 16-2 damaged framed

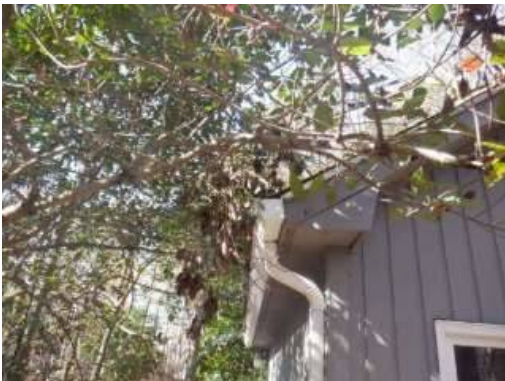
Trees were in contact with or were close to the building at one or more locations. Damage to the building can occur, especially during high winds, or may have already occurred (see other comments in this report). Recommend that a qualified tree service contractor or certified arborist remove trees as necessary to prevent damage to the building exterior. See Photo

Photo 17-1 (R) side roof; tree limbs touching roof

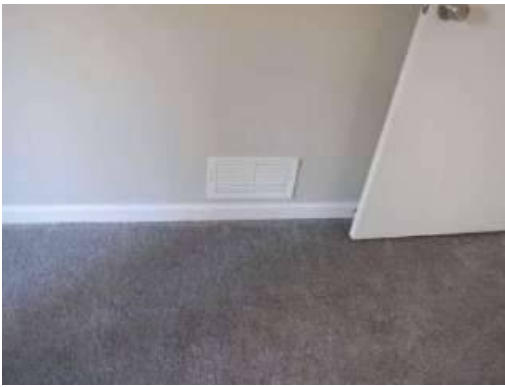
19) 🔧🔍 One or more "livable" rooms had no visible source of heat. Examples of livable rooms include bedrooms, kitchens and living/dining rooms, NOT hallways, closets or bathrooms. Livable rooms without heat (e.g. heat register, radiator, baseboard or wall heater) can be uncomfortable and have high levels of moisture. Depending on the client's needs, recommend consulting with a qualified heating contractor to determine options for modifying or improving the heating system per standard building practices.

Photo 19-1 Return vent

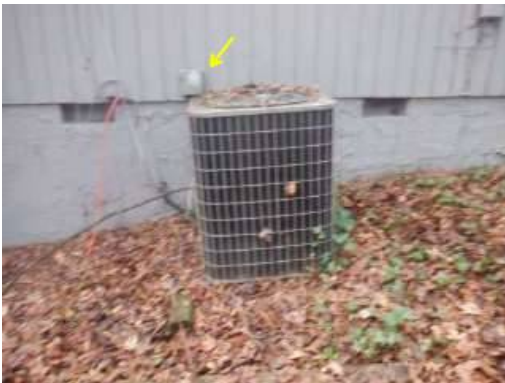
20) Permanent structures were too close to the heat pump or air conditioning condensing unit. There should be at least 12 inches of clearance on all sides and at least 4-6 feet above. Inadequate clearances around and above can result in reduced efficiency, increased energy costs and/or damage to equipment. Recommend making repairs or modifications as necessary to maintain these clearances, by a qualified contractor if necessary.

Photo 20-1 AC Conditioner blocking the fuse box

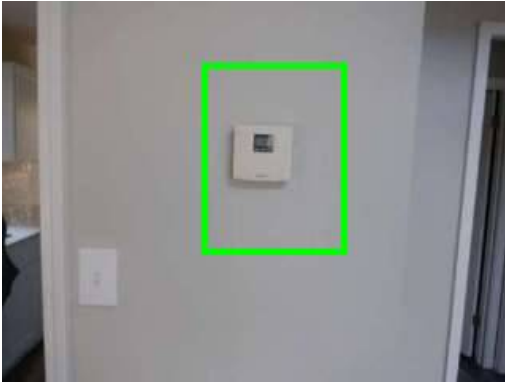
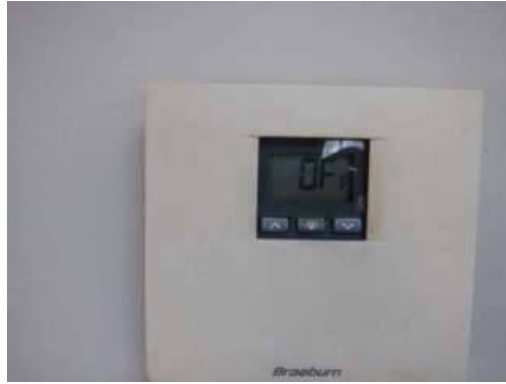
Photo 21-1

21) The heat pump or air conditioner condensing unit was not fully evaluated because the . Recommend that a full evaluation be made by a qualified person when conditions have been corrected so the system is operable. Note that the inspector does not operate or replace overcurrent protection devices, or operate any controls other than normal controls (thermostat).

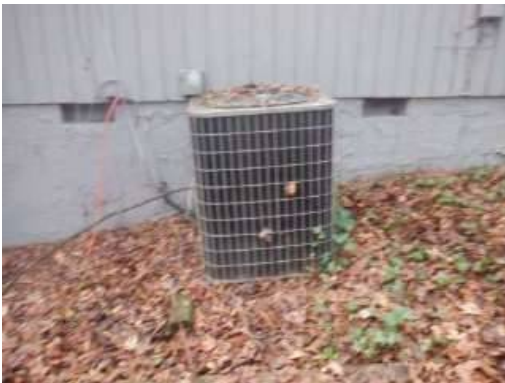
Photo 22-1

The heat pump or air conditioner condensing unit was not fully evaluated because the electricity supply was turned off. Recommend that a full evaluation be made by a qualified person when conditions have been corrected so the system is operable. Note that the inspector does not operate or replace overcurrent protection devices, or operate any controls other than normal controls (thermostat).

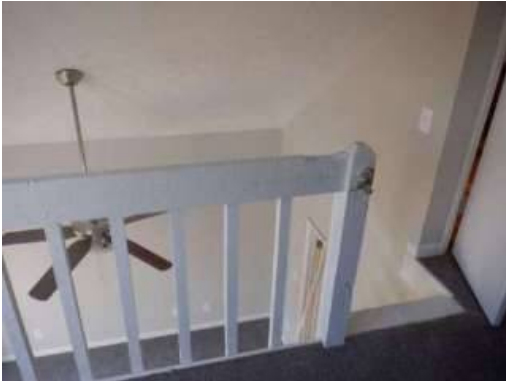
Guardrail should be 4", Steep stairway

Photo 24-1 (R) living area guardrail

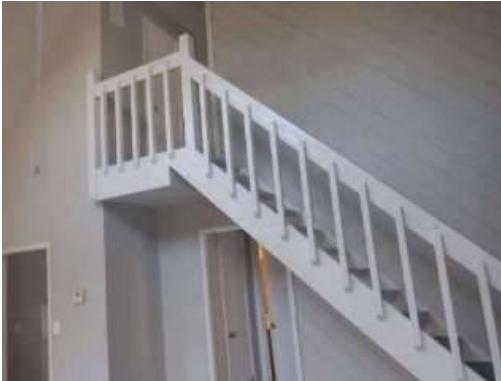
Photo 24-2 Guardrails should be 34"

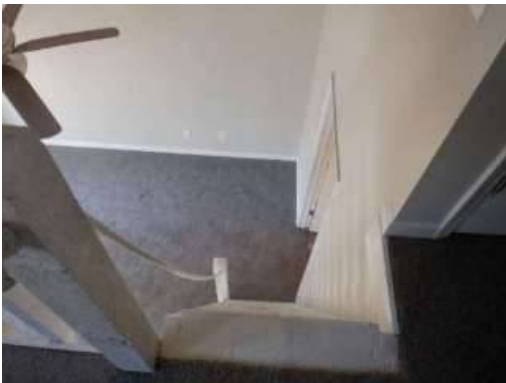
Photo 24-3 Steep stairway

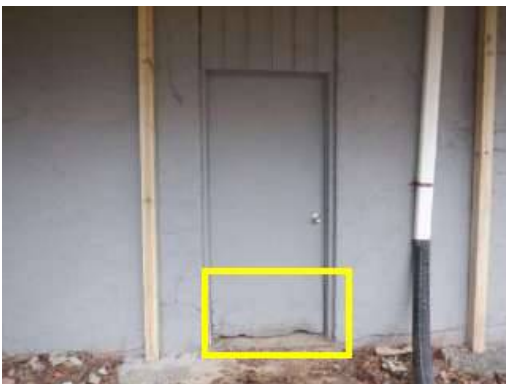
One or more exterior doors were significantly damaged or deteriorated. Recommend that a qualified person replace door(s) as necessary.

Photo 25-1 Crawlspace door entry

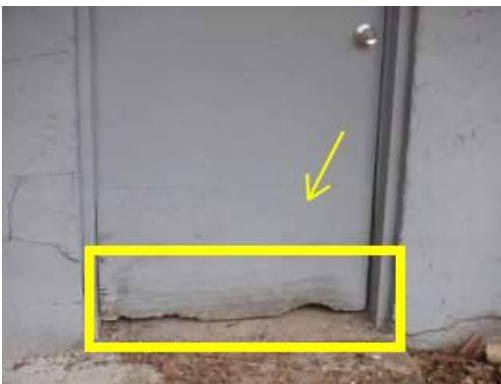
Photo 25-2 Bottom door rot

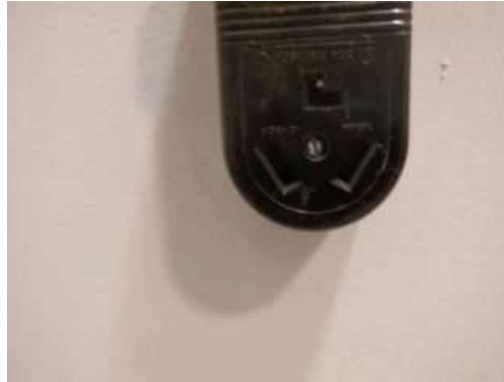
3 Prong Dryer outlet

Photo 26-2 3 Prong

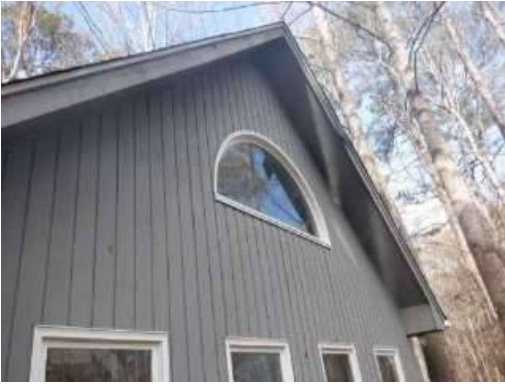
composition shingles were damaged. Leaks can occur as a result. This is a conducive condition for wood-destroying organisms. Recommend that a qualified contractor repair as necessary. For example, by replacing shingles.

Photo 27-1 Roof Shingle

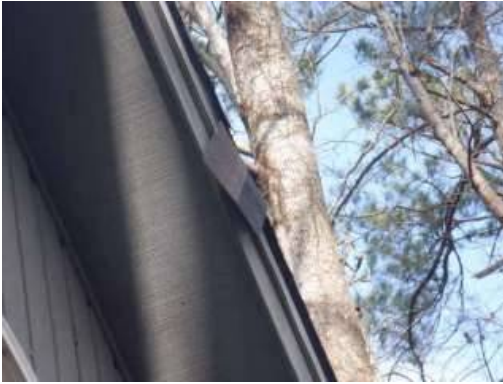
Photo 27-2 Loose shingle

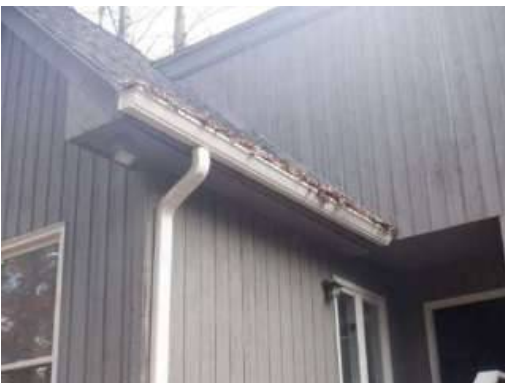
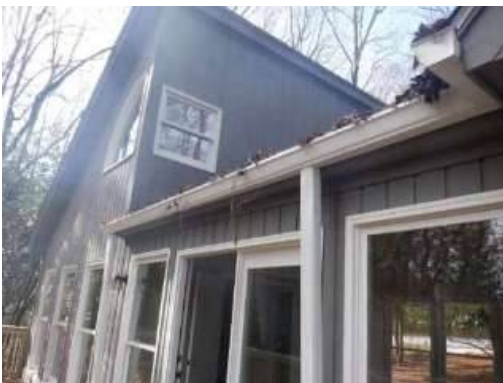
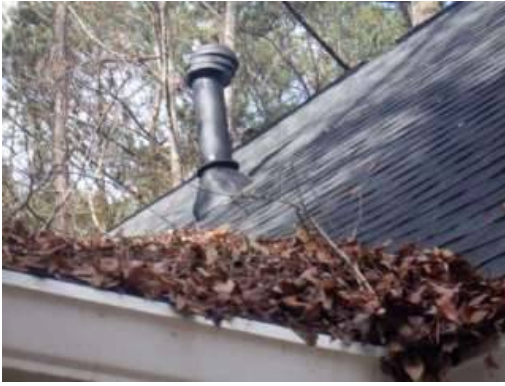
Significant amounts of debris have accumulated in one or more gutters or downspouts. Gutters can overflow and cause water to come in contact with the building exterior, or water can accumulate around the foundation. This is a conducive condition for wood-destroying organisms. Recommend cleaning gutters and downspouts now and as necessary in the future.

Photo 28-1 clogged gutter

Photo 28-2 clogged gutter

Photo 28-3 clogged gutter

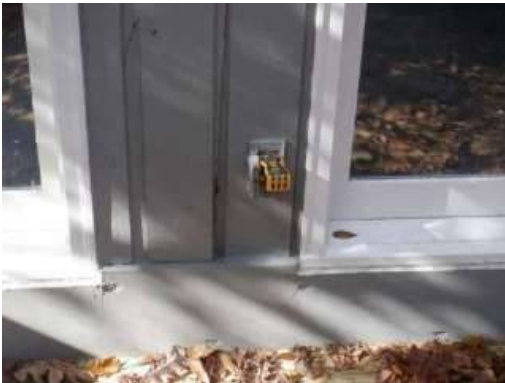
One or more ground fault circuit interrupter (GFCI) circuit breakers in panel(s) # wouldn't trip when tested. GFCI breakers reduce the chance of shock when using equipment in wet areas. This is a potential shock hazard. Recommend that a qualified electrician evaluate and repair as necessary.

Photo 29-1 Deck GFCI

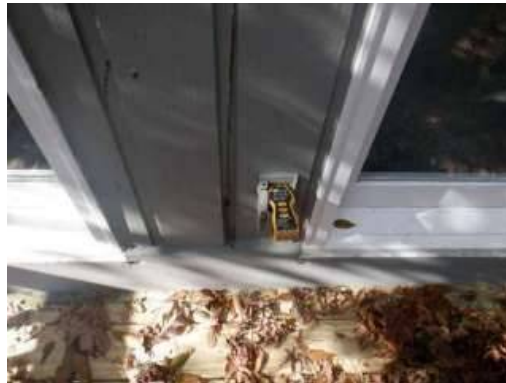
Photo 29-2 Deck GFCI outlet Not working

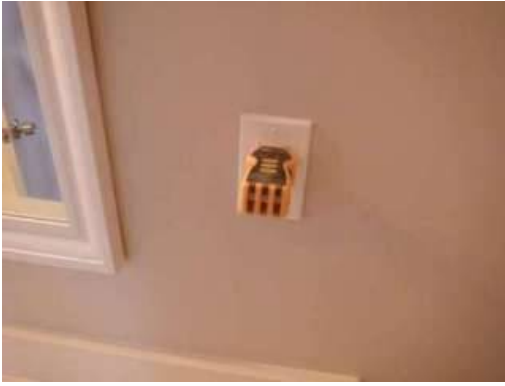
One or more ground fault circuit interrupter (GFCI) devices protecting receptacles at the bathroom(s), full bath and/or exterior wouldn't trip with a test instrument. This is a potential shock hazard. Recommend that a qualified electrician evaluate and repair as necessary.

Photo 30-1 First-floor Bathroom GFCi Outlet not working

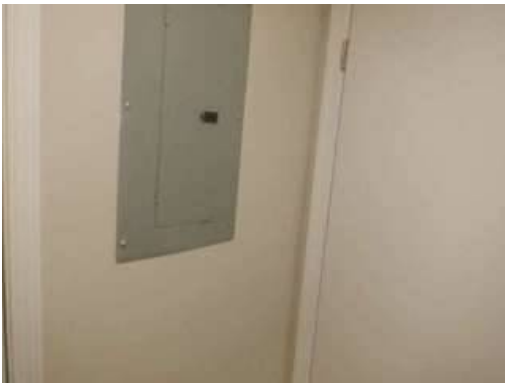
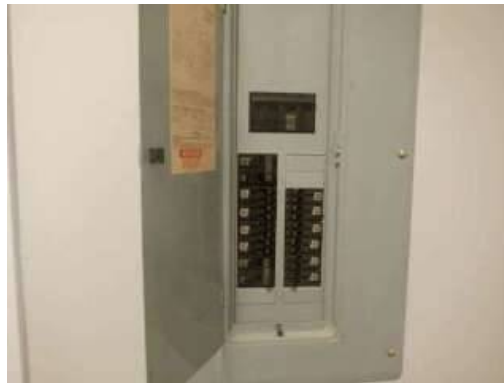
Photo 31-1 Main service panel

Panel(s) # were located in a bathroom. This is not an approved location for electric panels. Recommend that a qualified electrician move the panel(s) or make repairs per standard building practices.

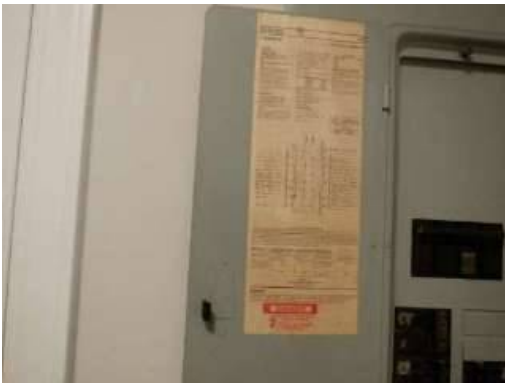
Photo 31-3 Main service panel
Label Hard to read

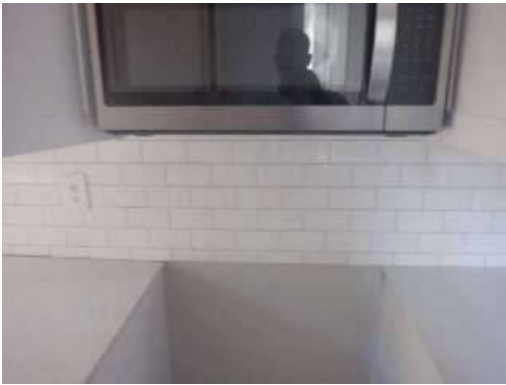
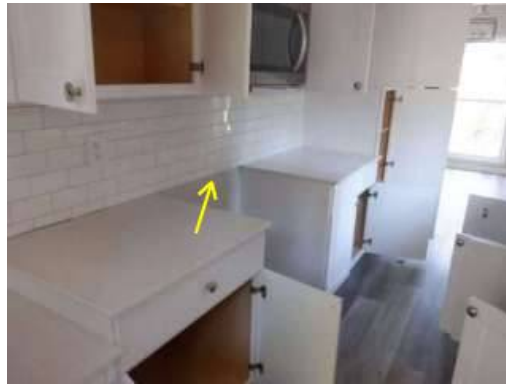
Photo 32-1 Microwave

The clearance between the stove top and the base of the exhaust hood above was too low. While the recommended height varies per the hood

manufacturer, standards usually call for a minimum of 24 inches of clearance. A low hood height can restrict visibility of the stove top. Recommend that a qualified contractor repair per standard building practices.

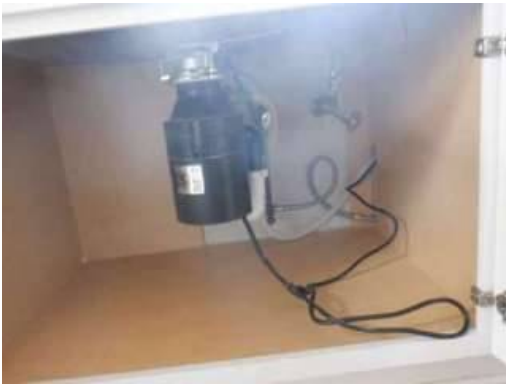
Photo 33-1 garbage disposal

33) Shouldn't be using a garbage disposal with a septic system
